**FINAL CONTRACT REPORT**

**GILES COUNTY, VA  
PEDESTRIAN BRIDGE COLLAPSE &  
FAILURE ANALYSIS**

*Project Manager*  
Jose Gomez, Virginia Transportation Research Council

Virginia Transportation Research Council  
(A partnership of the Virginia Department of Transportation  
and the University of Virginia since 1948)

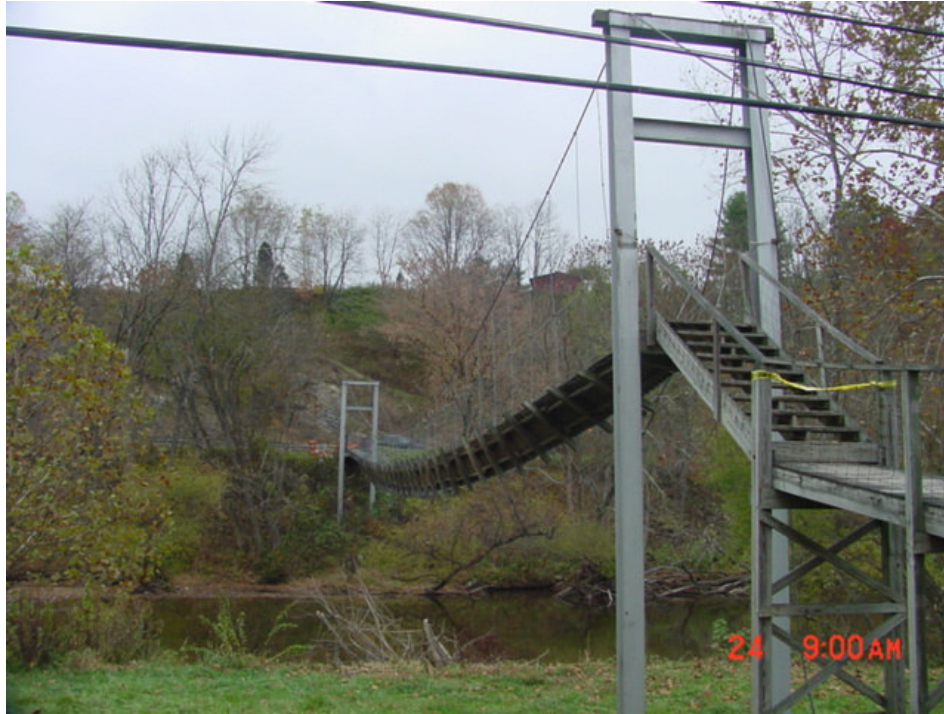
**Figure 1. Giles County Pedestrian Bridge.**

The pedestrian bridge over Walker Creek is a suspension bridge with a 160 ft main span. Figure 1 shows the bridge after failure. The suspension cables are 1 in. in diameter. At each end of each cable, the cable is attached to a 1 in. diameter galvanized steel bar, bent into a closed hook and embedded in a large concrete dead-man. The floor beams are spaced every 5 ft, and are rough cut 4 x 4s. It is believed that all timber components of the bridge are treated pine. Two stringers are supported by the floor beams. The stringers are rough cut 2 x 4s, and they appear to be 12 ft long, lapped at every other floor beam (see Figure 2). The decking is rough cut 1 x 6s approximately 36 in. long, spanning across the stringers. The suspender cables are 3/8 in. diameter cables, and the bridge has a wire mesh guard fence on each side.

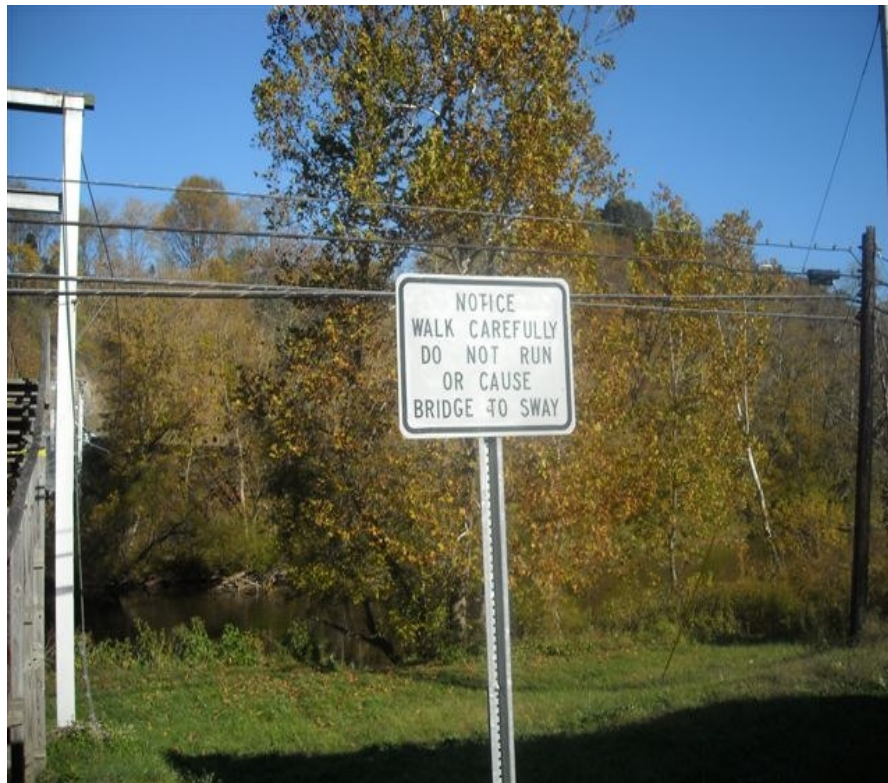
**Figure 3. Intact sign located at each end of bridge.**

Anchor rods were viewed and verified as good. The signage was verified as in place. The sign is shown in Figure 3.

The stringers were rough cut 2 x 4's, 12 ft long, lapped approximately every 10 ft. The lap splicing of the stringers can be seen in Figure 3. It was also assumed that a treated pine was used for the stringers. As for the floor beams, the unit weight was assumed to be approximately 40 lb/ft<sup>3</sup>. Therefore, the distributed load of two 2 x 4 stringers was 4.44 lb/ft. This was increased by 10 percent to 4.9 lb/ft to account for the splicing.

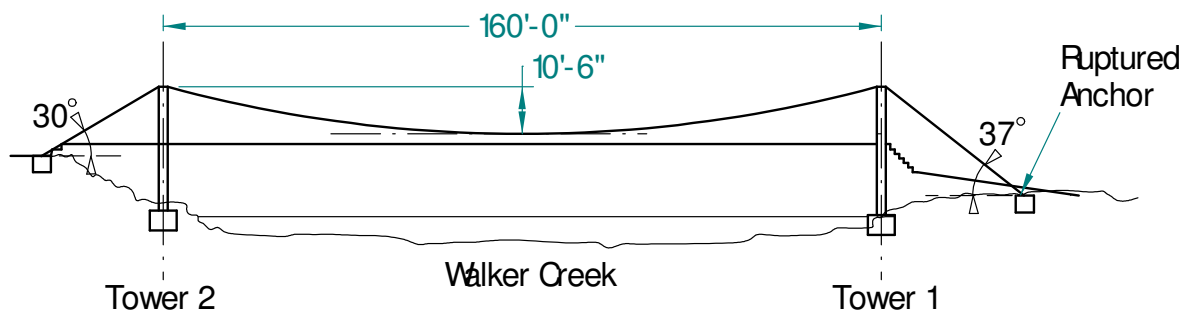
**Figure 4. Dimensions Used for Analysis of Suspension Bridge.**

Finally, note that the cable that remains at the bridge site has a calculated axial force and moment, based on 1 ½ in. eccentricity, that falls between the increased yield line and the ultimate strength line. Photographs of the existing anchors (see the 37 degree backstay anchor in Figure 4) indicate that the anchor has opened significantly. The degree of opening of the 37 degree back stay anchor is similar to that seen in the tested anchor in Figure 14(i) at a load of 11.9 kips. This is higher than the calculated load of 10.6 kips (see Table 2), but there may have been a dynamic load effect at the time of collapse. This would have caused the anchor to temporarily see a higher load than 10.6 kips, and exhibit larger deformations, accordingly.

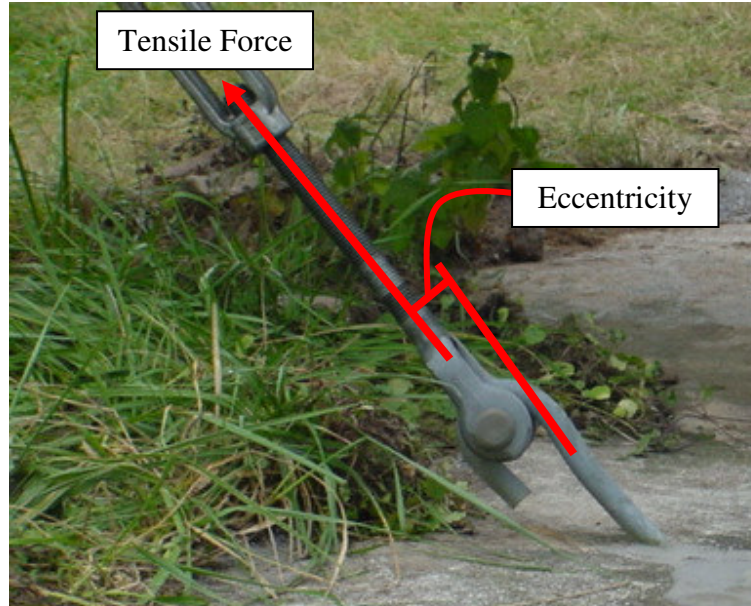
Figure 5. Anchor Geometry and Eccentricity

The goal of the laboratory test setup was to reproduce the loading conditions experienced by a typical cable anchor rod at the Giles County footbridge. This involved pulling the anchor in tension while inducing a moment in the specimen due to the geometry of the anchor as shown in Figure 5. The eccentricity from the line of action of the tensile force to the centerline of the anchor body was measured to be approximately 1 ½ in.

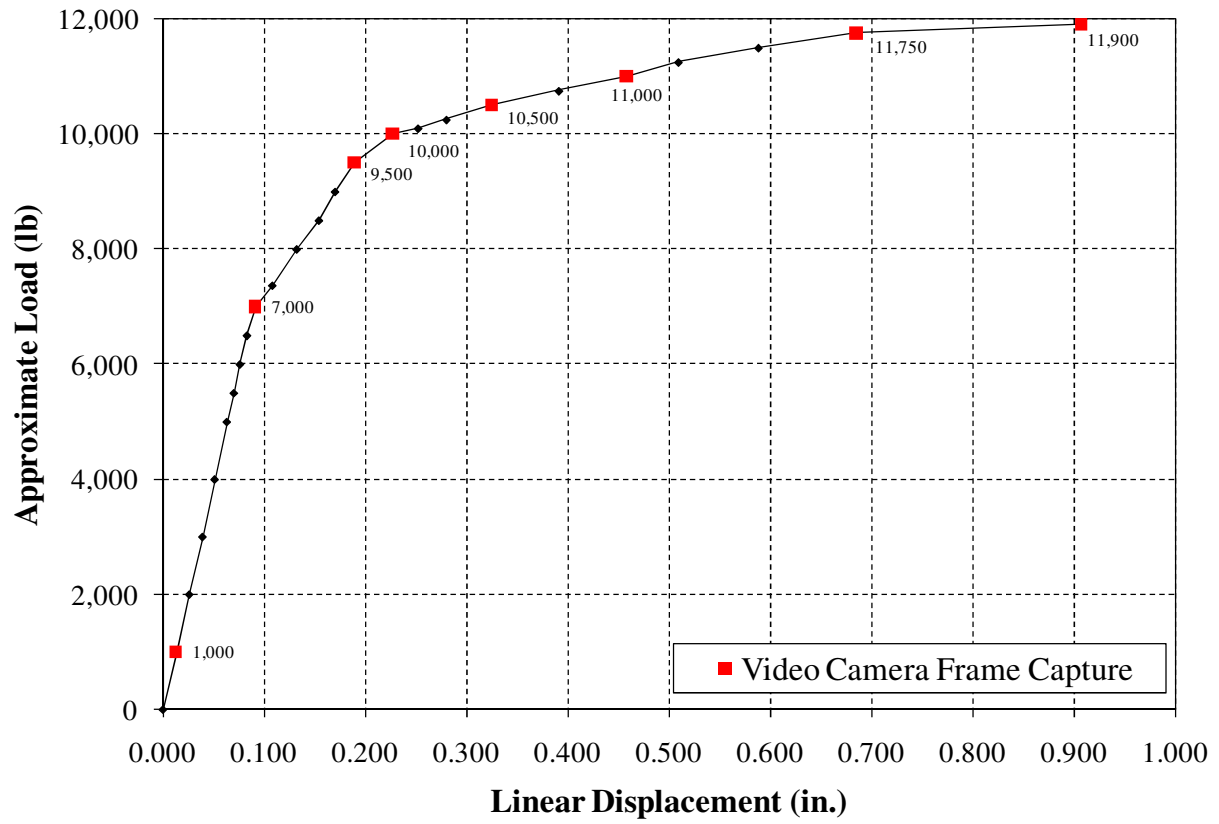
**Figure 13. Load vs. Linear Displacement**

During the test, the load was increased in 1,000 lb increments, proceeding until 5,000 lb of tension were applied to the anchor rod. After this point, the load was increased in 500 pound increments from 5,000 lb to 10,000 lb of tension. Finally, the load was increased in 250 pound increments from 10,000 lb until the final load of 11,900 lb of tension was reached. At each load increment, measurements of linear displacement of the threaded rod load cell were recorded. A plot of approximate load vs. deflection can be seen in Figure 13. Additionally, Figure 13 highlights certain loads that correspond with a frame from the video taken during testing. All of the video frames are shown Figure 14(a) through Figure 14(i). The load is taken as approximate due to loss of hydraulic pressure and slight decreases in load as dial gage measurements were taken.

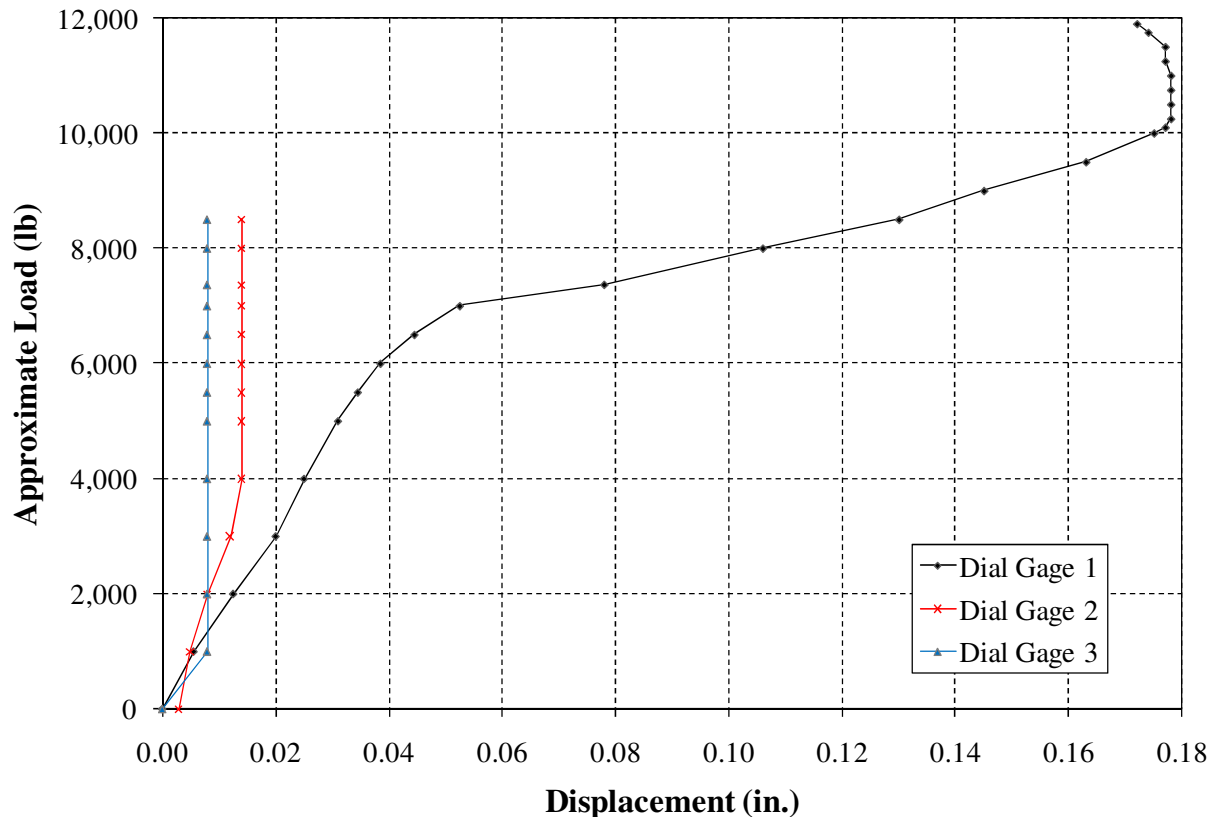
**Figure 15. Load vs. dial Gage Displacement**

Figure 14 and Figure 15 also display how the anchor hook opened with increasing load. Figure 15 exhibits this trend as dial gage 1 indicates large increases in displacement from 1,000 lb to 10,000 lb. Through this time period, the shaft of the anchor rod is straightening while the hook of the anchor maintains relatively the same shape (as shown in Figure 14 (a) through (c)). Finally, the anchor achieved some equilibrium at approximately 10,000 lb as dial gage 1 exhibits more of a straight vertical line.

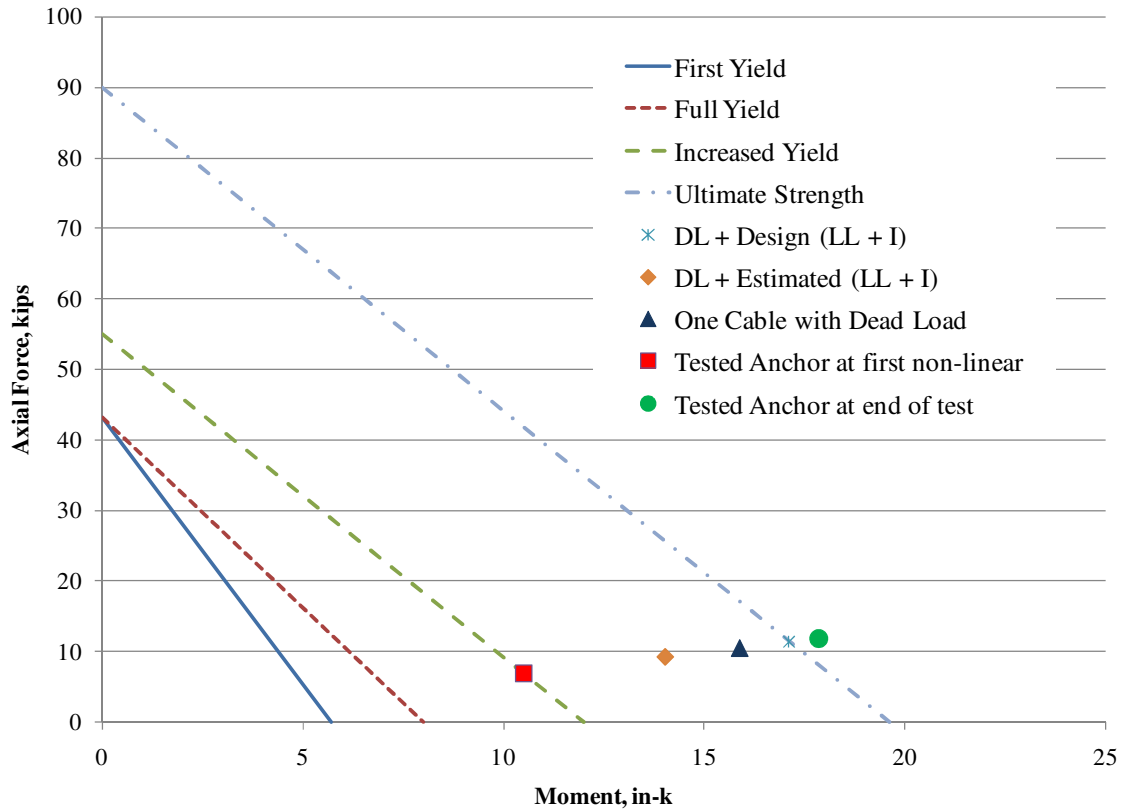
**Figure 18. Moment - Axial Force Interaction Diagram**

Based on the processes described in the Methods section, four moment-axial force interaction diagrams were constructed. They are presented in Figure 18. Also shown on the plot are several points indicating force and moment combinations on the anchor rod at the bridge site and during laboratory testing.

Note that the first point from the testing program was at a load of 7 kips and a moment, assuming a 1 ½ in. moment arm, of 10.5 in-kips. This falls very close to the interaction line calculated based on full yielding of the cross-section considering increased yield strengths as determined by Wright. During testing, at 7 kips the specimen started to show non-linear behavior, based on the deformation in the direction of the applied load (see Figure 13) and based on deformation perpendicular to the applied load (see Figure 15, dial gage 1). The observation that inelastic behavior was not apparent at lower loads, closer to the first yield line in Figure 18, supports Dr. Wright's conclusion that the rod had higher yield strength at the surface than at the center of the rod.

Also note that the second point from the testing program was at a load of 11.9 kips and a moment, also assuming a moment arm of 1 ½ in., of 17.9 in-kips. This point falls outside the interaction line. The test was halted because it was believed that the rod was very close to rupture, and this is confirmed by its proximity to the failure interaction line.

The axial force and moment combination assumed to be on the bridge at the time of collapse falls between the increased yield line and the ultimate strength line. This reinforces Dr. Wright's conclusion that, at the time of failure, the bar had experienced a small amount of ductile yielding, but premature fracture was initiated by the presence of the flaw.

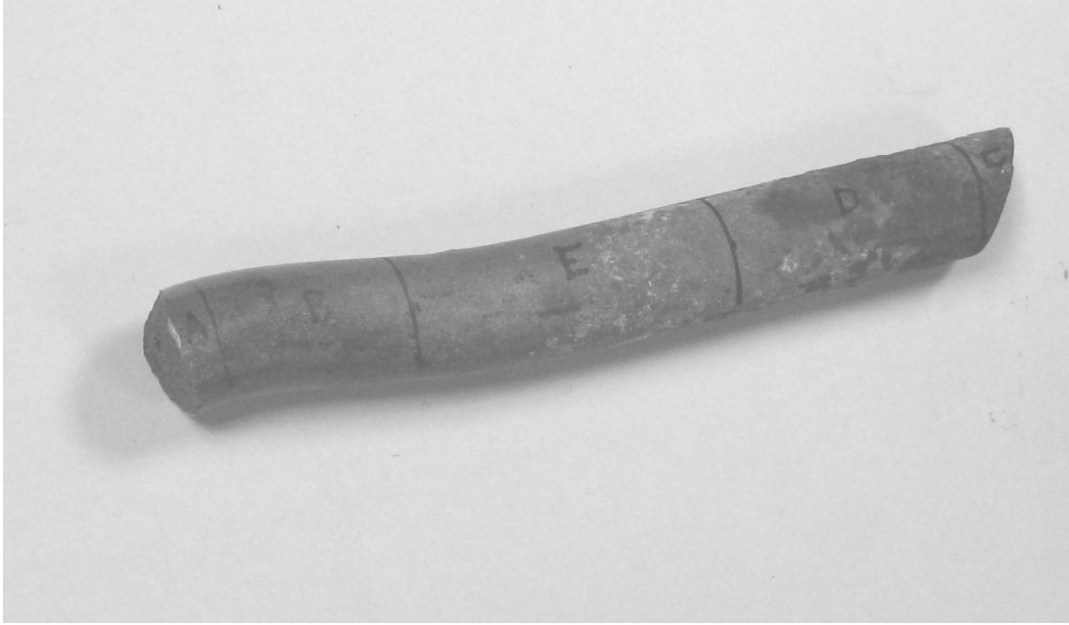
**Figure 2** Section of failed anchor rod for failure analysis.

Figure 2 shows the failed anchor rod section that was delivered to TFHRC. After a preliminary visual examination, the rod was sectioned into five pieces for further testing as shown in figures 2 and 3.

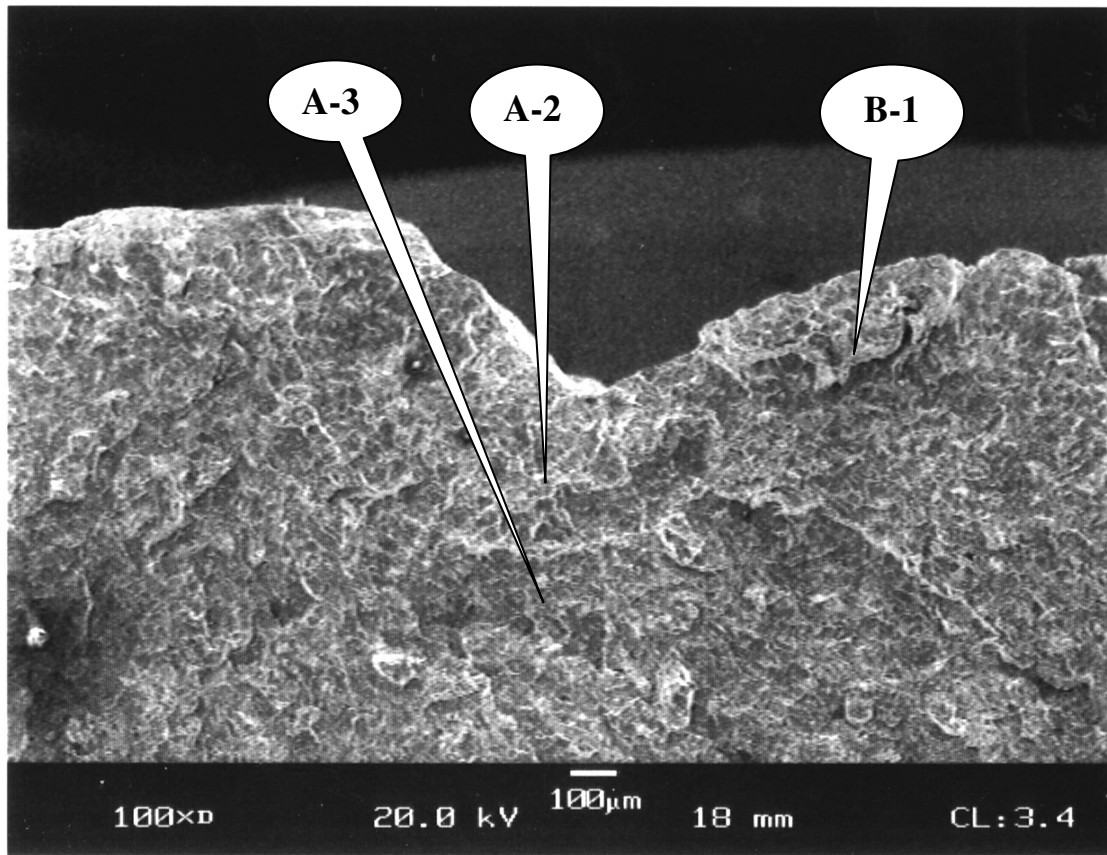
**Figure 13** Location of close-up locations for SEM figures.

A ½" square piece of the fracture surface containing the initial defect was mounted and examined under a scanning electron microscope (SEM). Figure 13 shows a low power view of the crack-like defect that was determined to be the fracture initiation site. The locations for the following close-up images are shown in the figure. Virtually the entire surface of the crack-like defects was examined during the scanning procedure. The following close-up images can be considered typical.
